# Property Inspection Report

**404 NE High Street**  
**Inspection Prepared For: Jenn Bomberger**  
**Agent:**

**Date of Inspection: 8/13/2025**

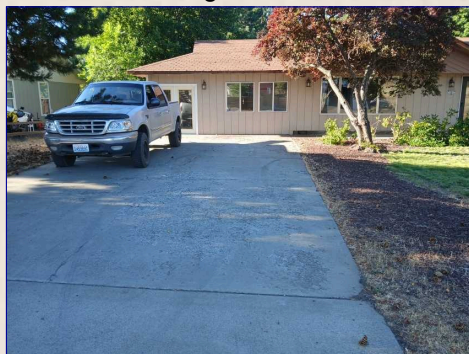
- The driveway has areas of spalling. Spalling is a common surface imperfection. Recommend a professional contractor repair to help prevent additional damage.

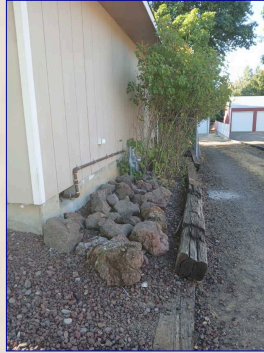
There is vegetation in contact with the house. Recommend trimming trees/vegetation, so it is doesn't come into contact with the home.

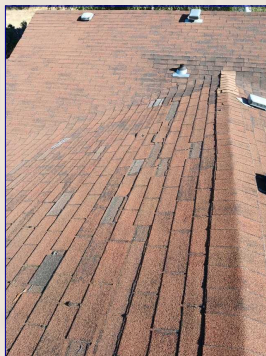
| Page 13 Item: 5 | Condition of Roof Covering | <ul style="list-style-type: none"> <li>• Missing tabs or shingles on the roof, recommend a licensed roofer repair or replace.</li> <li>• The roof was in poor condition and will need repair or replacement by a professional roofer soon.</li> </ul> |

Missing tabs or shingles on the roof, recommend a licensed roofer repair or replace.

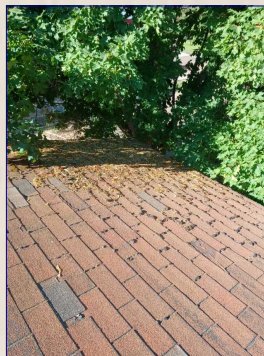
The roof was in poor condition and will need repair or replacement by a professional roofer soon.

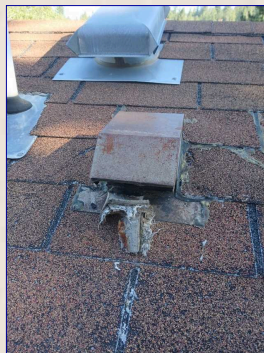
The driver vent needs to be thoroughly cleaned. Or replaced, it's not operable and it is clogged.  
On the roof

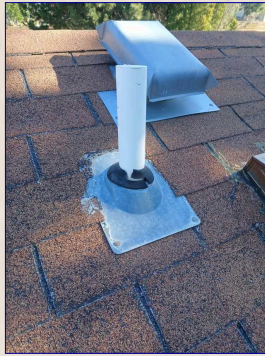
| Page 13 Item: 6 | Vents | <ul style="list-style-type: none"> <li>• The rubber boot on the plumbing vent is old and cracked, which can allow water to penetrate and cause damage to the roof coverings. Recommend a licensed roofer repair.</li> </ul> |

The rubber boot on the plumbing vent is old and cracked, which can allow water to penetrate and cause damage to the roof coverings. Recommend a licensed roofer repair.

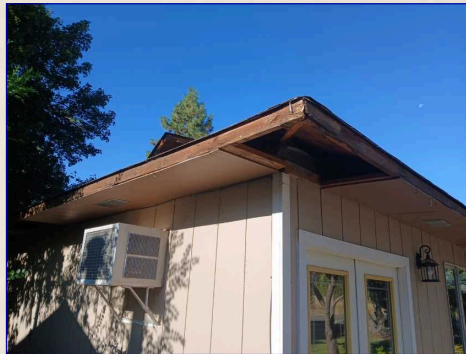
| Page 14 Item: 1 | Gutters | <ul style="list-style-type: none"> <li>• Gutters were not installed on the home. Recommend a licensed contractor install gutters to properly direct water flow away from the home and foundation.</li> </ul> |

Gutters were not installed on the home. Recommend a licensed contractor install gutters to properly direct water flow away from the home and foundation.

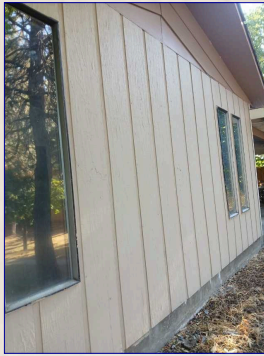
The siding needs routine repair and painting maintenance. Recommend a licensed contractor to repair and paint the siding.

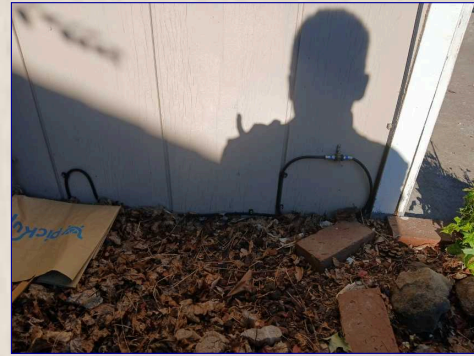
| Page 14 Item: 2 | Siding | <ul style="list-style-type: none"> <li>• The siding is in contact with the soil. Recommend a professional contractor evaluate and repair.</li> </ul> |

The siding is in contact with the soil. Recommend a professional contractor evaluate and repair.

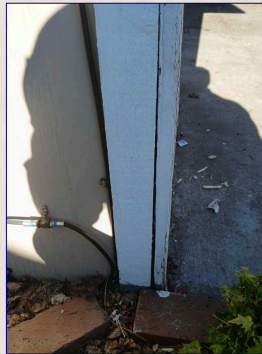
| Grounds | | |
|---|---|---|
| Page 15 Item: 3 | Trim | • Some of the trim was damaged. Recommend repair or replacement of damaged exterior trim by a licensed contractor. |

Some of the trim was damaged. Recommend repair or replacement of damaged exterior trim by a licensed contractor.

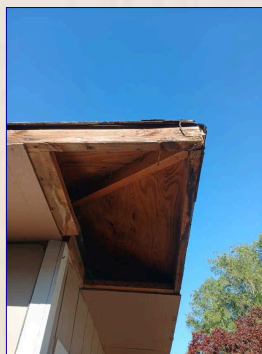
Soffit is missing in one or more locations. Recommend a licensed contractor

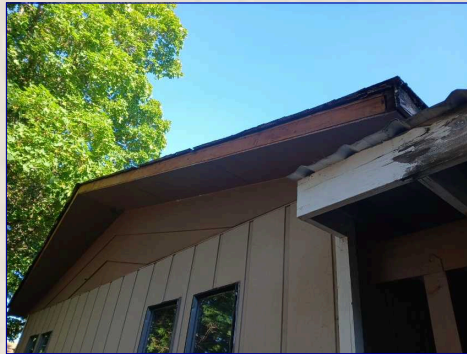
Fascia is missing in one or more areas. Recommend licensed contractor to repair or install

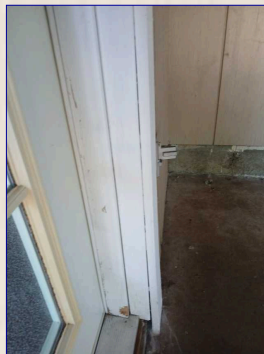
| Grounds | | |
|---|---|---|
| Page 16 Item: 6 | Caulking | • Recommend caulking around windows, doors, corners, and utility penetrations to prevent moisture and pest intrusion. |

Recommend caulking around windows, doors, corners, and utility penetrations to prevent moisture and pest intrusion.

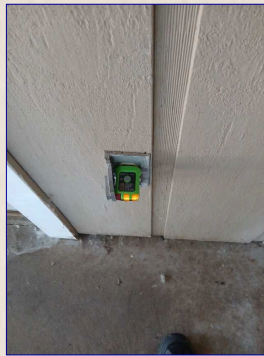
GFCI receptacles are not installed at outdoor locations, which is a safety concern. Recommend a licensed electrician install GFCI receptacles.

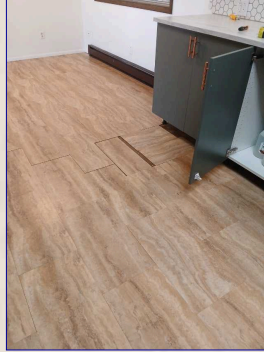
| Page 20 Item: 7 | Floor | <ul style="list-style-type: none"><li>• The floor covering in the kitchen is damaged, which is a potential trip hazard. Recommend repair/replace as needed.</li></ul> |

The floor covering in the kitchen is damaged, which is a potential trip hazard. Recommend repair/replace as needed.

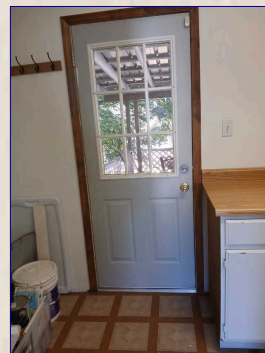
The door stop is missing. Recommend installing a doorstop. Doorstops help prevent damage to the wall from the doorknob.

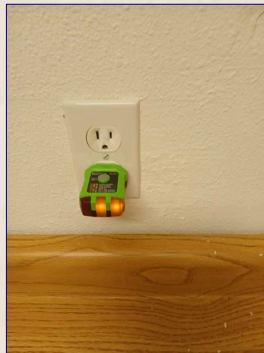
| Page 22 Item: 5 | Electrical | <ul style="list-style-type: none"> <li>• There are missing <b>GFCI</b> receptacles in the laundry room, which is a safety concern. Recommend a licensed electrician install GFCI receptacles.</li> </ul> |

There are missing GFCI receptacles in the laundry room, which is a safety concern. Recommend a licensed electrician install GFCI receptacles.

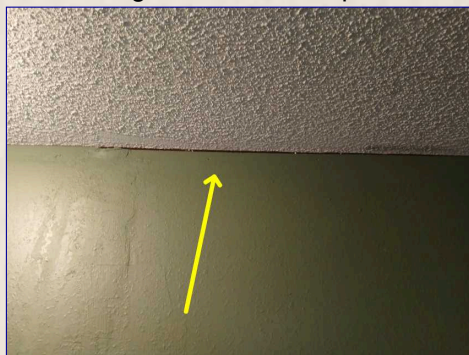
There are holes present in the wall/ceiling. Recommend a professional contractor repair.

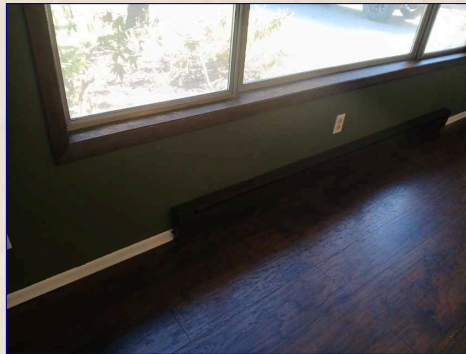
Baseboard in the living room is not functioning at time of inspection. Recommend further evaluation

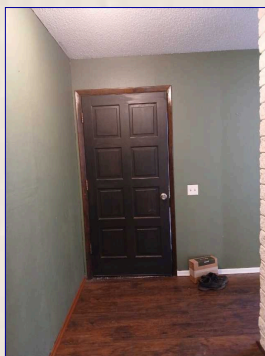
Recommend installing a doorstop. Doorstops help prevent damage to the wall from the doorknob.

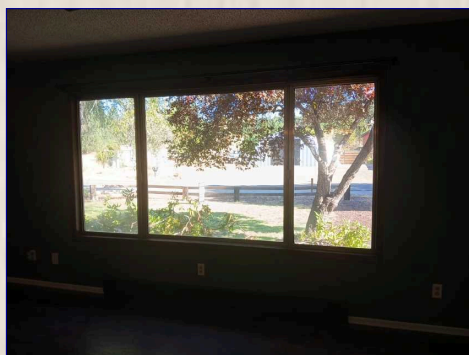
Some window screens are torn, damaged, or missing. Repair/replace as needed.

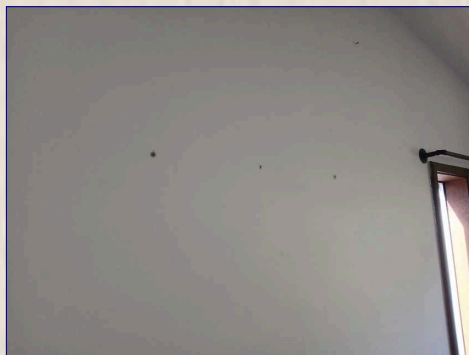
There are holes present in the wall/ceiling. Recommend a professional contractor repair.

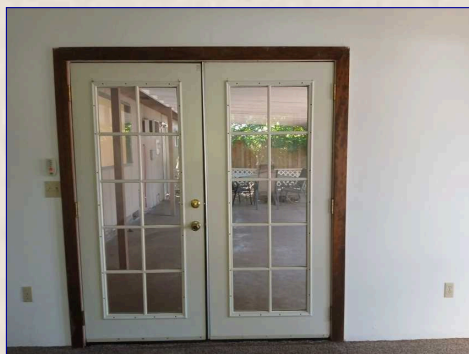
Recommend installing a doorstop. Doorstops help prevent damage to the wall from the doorknob.

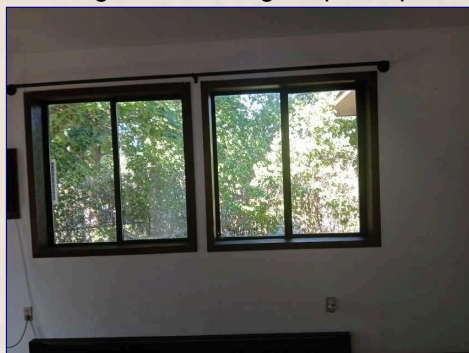
Some window screens are torn, damaged, or missing. Repair/replace as needed.

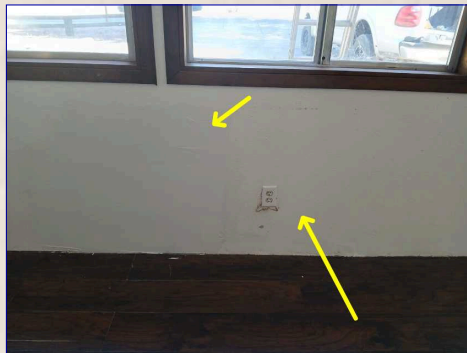
There are holes present in the wall/ceiling. Recommend a professional contractor repair.

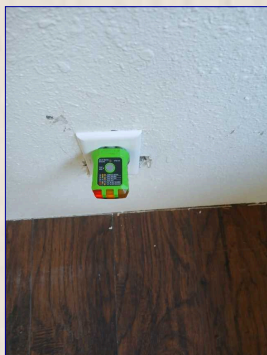
Reverse polarity exists at the receptacles in the room, which is a safety concern. Recommend a licensed electrician repair.

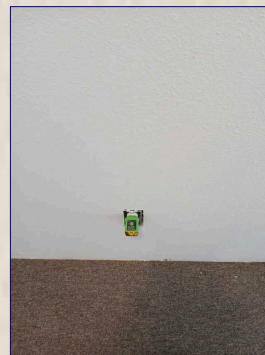
At least one cover plate is missing at a receptacle in the room, which is a potential safety concern. Recommend installing cover plates.

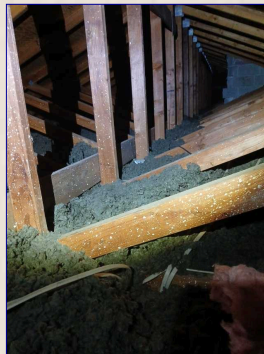
| Grounds | | |
|---|---|---|
| Page 39 Item: 2 | Insulation | • The attic insulation is not sufficient for current building standards. Recommend a licensed professional add additional insulation. |

The attic insulation is not sufficient for current building standards. Recommend a licensed professional add additional insulation.

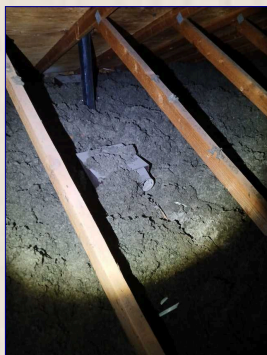
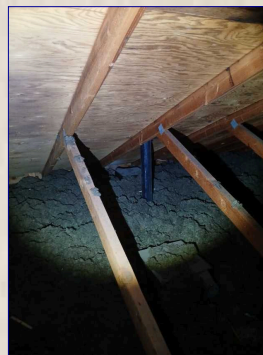
| Grounds | | |
|---|---|---|
| Page 39 Item: 4 | Fans exhaust to | • Bathroom vents terminate in the attic. Recommend extending bathroom vents in the attic to the exterior. |

Bathroom vents terminate in the attic. Recommend extending bathroom vents in the attic to the exterior.

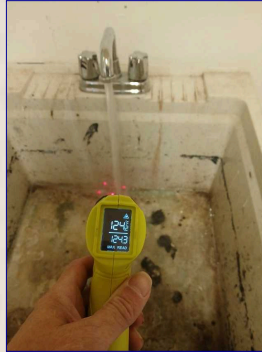
The water temperature is greater than 120 degrees, which is a scalding concern and safety concern. Recommend reducing the temperature. Consult a professional contractor as needed.

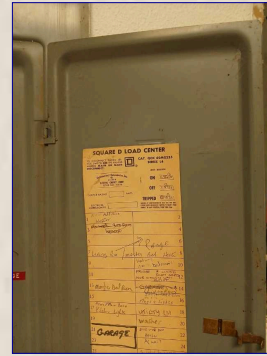
| Page 43 Item: 1 | Main Panel General | <ul style="list-style-type: none"> <li>• The electrical service panel was a Square D panel that was manufactured by Schneider Electric. Recalled products are not part of the home inspection, however certain Square D QO load centers with plug in neutral load bars overheat, posing thermal burn and fire hazards and apparently are currently under a recall. Circuit breaker boxes with covers that were manufactured between December 2019 and March 2022 are also included in this recall. Recommend contacting Schneider Electric to arrange a licensed electrician trained in the repair or replacement of the affected panels to repair or replace as directed.</li> </ul> |

The electrical service panel was a Square D panel that was manufactured by Schneider Electric. Recalled products are not part of the home inspection, however certain Square D QO load centers with plug in neutral load bars overheat, posing thermal burn and fire hazards and apparently are currently under a recall. Circuit breaker boxes with covers that were manufactured between December 2019 and March 2022 are also included in this recall. Recommend contacting Schneider Electric to arrange a licensed electrician trained in the repair or replacement of the affected panels to repair or replace as directed.
