# Property Inspection Report

**404 NE High Street**  
**Inspection Prepared For: Jenn Bomberger**  
**Agent:**

**Date of Inspection: 8/13/2025**

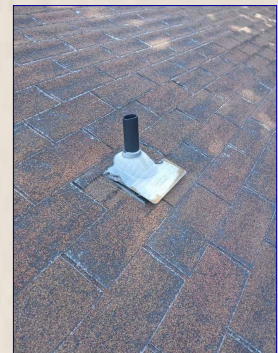
The Plumbing Vent(s)

- The Roof Vent(s)
- The plumbing vent is too low. Recommend a qualified contractor repair.
- The rubber boot on the plumbing vent is old and cracked, which can allow water to penetrate and cause damage to the roof coverings. Recommend a licensed roofer repair.

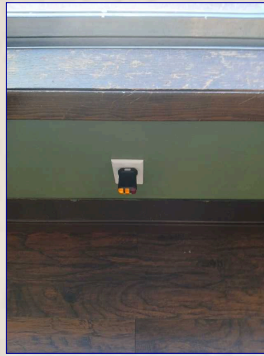
Electrical receptacle operating

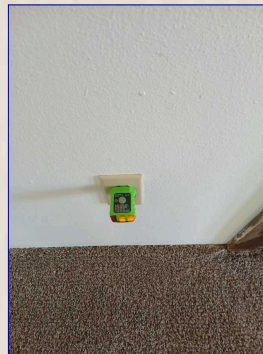
Electrical receptacle operating

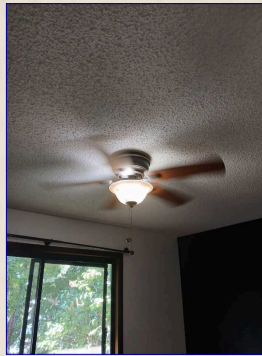
Ceiling fan operating
