# Property Inspection Report

**404 NE High Street**  
**Inspection Prepared For: Jenn Bomberger**  
**Agent:**

**Date of Inspection: 8/13/2025**

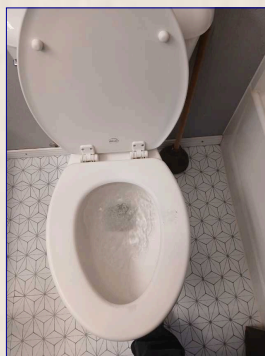
Toilet operating

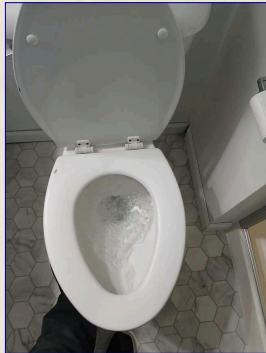
Toilet operating

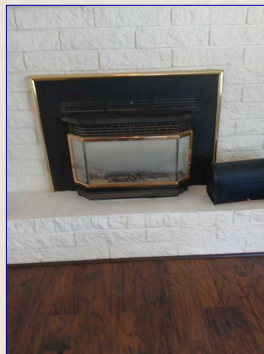
The Fireplace View

- The fireplace was not operational at the time of the inspection. For added safety, we recommend a licensed contractor evaluate and repair prior to use or closing.
